## Problem report 8-9-08

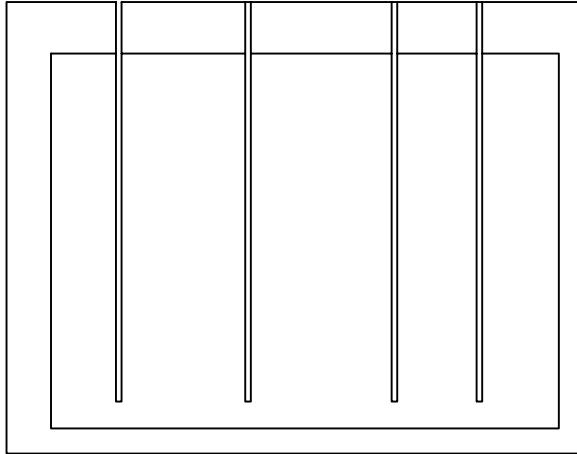
①

1- Chips are embossed with the wires inside resulting in a very sturdy chip. The wires are pulled out using pliers after fixing the chip using a vise

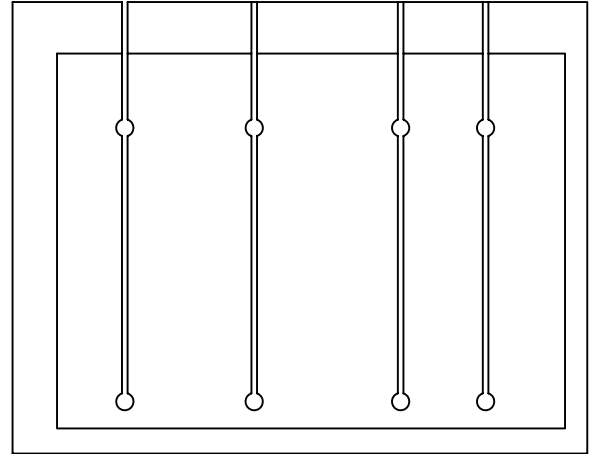
②

2- Wells are drilled carefully to penetrate only the cover. and 4cm from the bottom wells the top wells are drilled as well. now the channel is still open and not sealed from the upper edge.

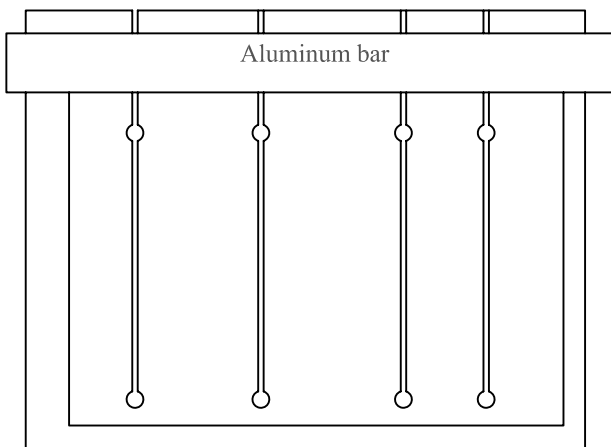
③

3-Using an aluminum bar the chip is sealed from the top leaving enough space to stick the ports

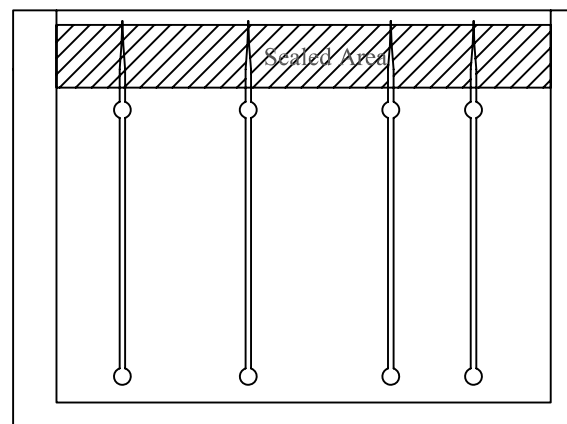
④

4-The sealing results in complete deformation and closing of the part of the channel beneath the aluminum and no solution could reach that part beyond the well lack of ventilation.

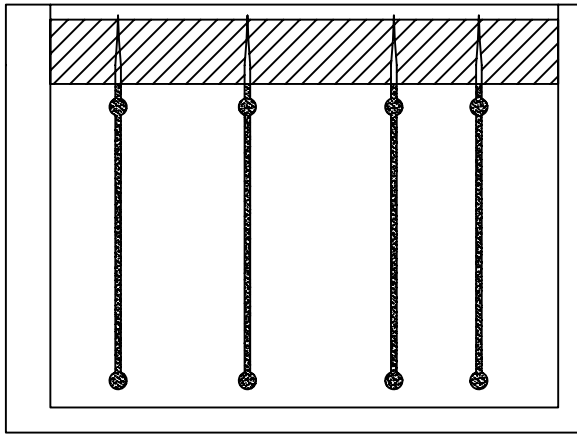
5

5-Filling up the channel with grafting solution in particular and irradiating it would result in the fracture patterns seen in figure -6- strictly around the sealed side of chip and the corresponding wells.

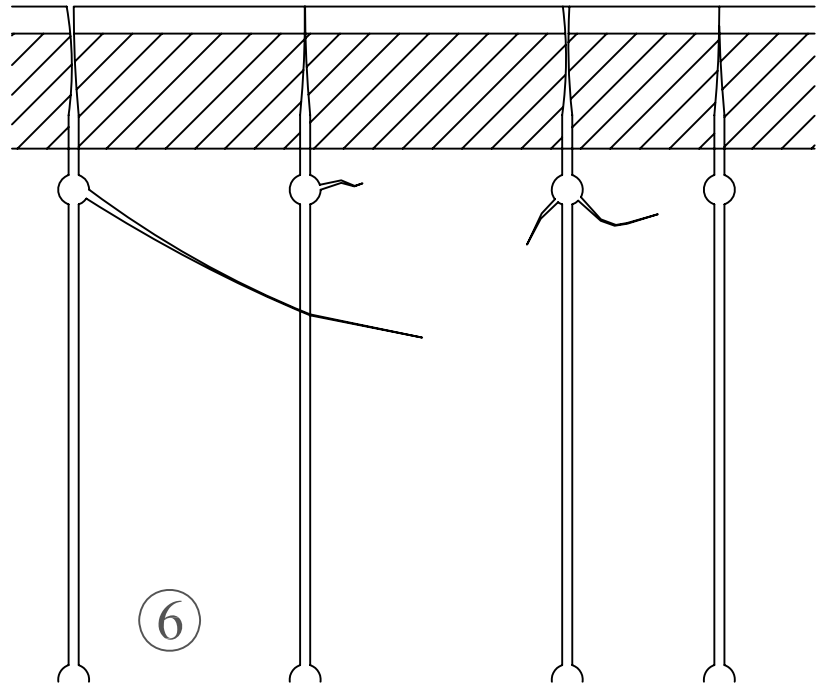
6

\*The sealed band on the top would stiffen up and crack exposing the channel that was once sealed.

\*My preliminary conclusion is that the "stretched "plastic at the sealing site is somehow getting affected by the energy and the grafting solution is playing a major role in facilitating this causing the plastic to rebound breaking the material

\*These cracks are through the whole depth of the chip not merely base or cover, and they propagate cutting the chip in half.

\*Solving this problem is technically easy and is achieved by leaving the sealing to be the very last step. It is very easy to fill the channels and pump in the monolith and SPE even if the channel is open at the end.
